**Structural Report
100 N. Main
Wauconda, Illinois**

Prepared By:
Victor G. Carsello, S.E., President
Carsello Engineering Inc.
2656 Wild Timothy Road
Naperville, IL 60564
630-854-9567
Carsello Engineering Project No. 23096

September 27, 2023

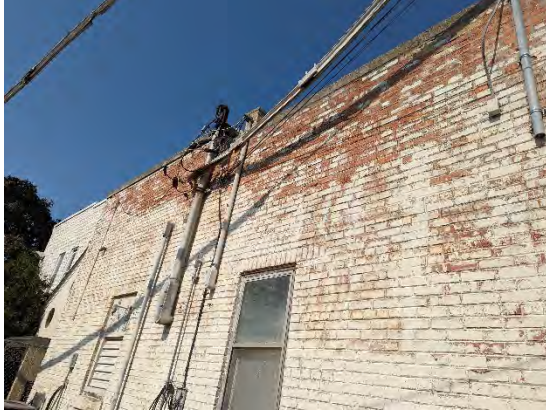
2. The exterior veneer is due for an overall repointing and general maintenance. Spalled and cracked brick should be replaced. (*Photo 1*)
3. There does not appear to be any flashing or weeps above the lintels. There is evidence that water has entered behind the veneer causing the lintels to rust and subsequently cracking the brick. (*Photo 2*)

Photo 1: Spalled brick on East elevation

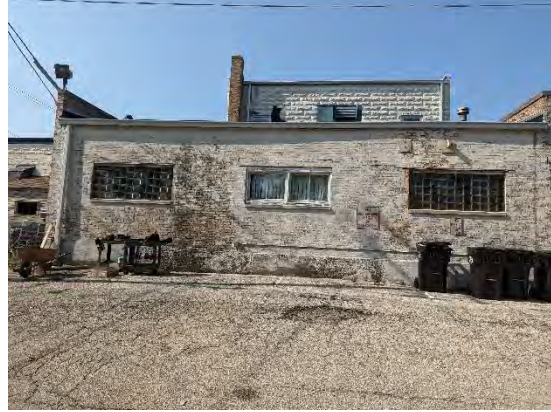
Photo 2: Lintels at rear elevation

- Address the rear wall settlement. Assume 6 helical piles bracketed to the foundation wall.
- Rebuild the SW corner brick and CMU. Add reinforcing in CMU wall.
- Reinforce back CMU by providing reinforcing steel at window jambs and at 4'-0" on center, grouted into the existing wall.
- Expose steel lintels and replace if rusted. Provide proper flashing.
- Repoint the brick veneer, replace spalled bricks, and ensure coping is water-tight.
- Repair roof at gutter to ensure water is not entering the wall.
- Replace west sidewalk and patch spalled stair wall.

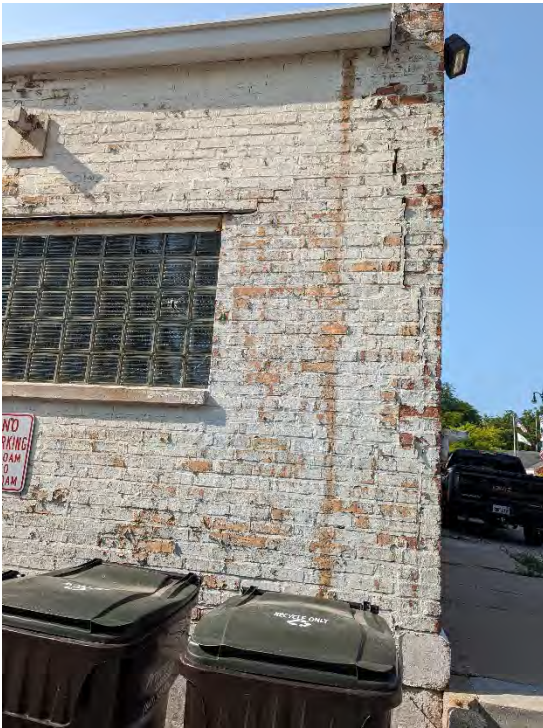
4. The rear wall has experienced movement. Based on some of the cracking patterns, the wall has most likely settled. The wall also appears to be bowing outward at the head of the windows. There are also large horizontal cracks in the CMU that are visible from the inside of the space. This movement has also affected the masonry on the west elevation at the mandoor. There are cracks visible on both the brick veneer and CMU. (*Photo 3, 4 5, 6 and 7*)

Photo 3: NW corner cracking

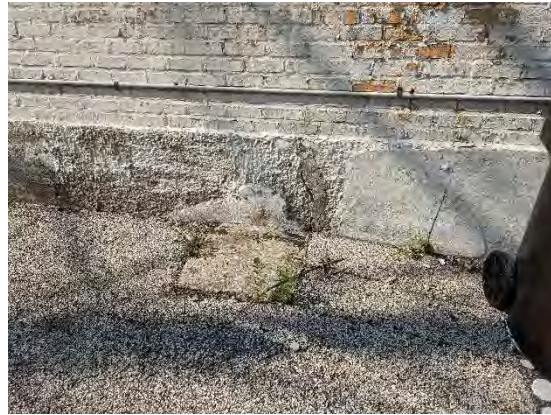
Photo 4: Foundation cracking

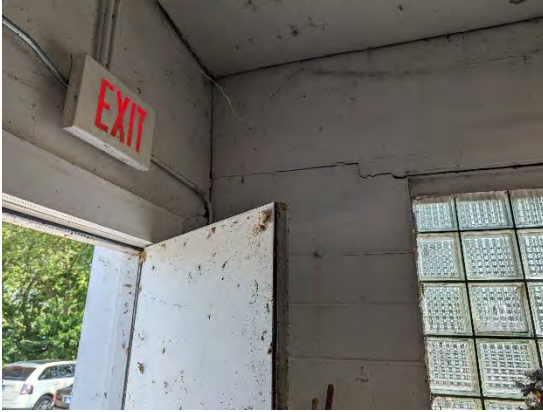
Photo 5: Interior view of NW corner

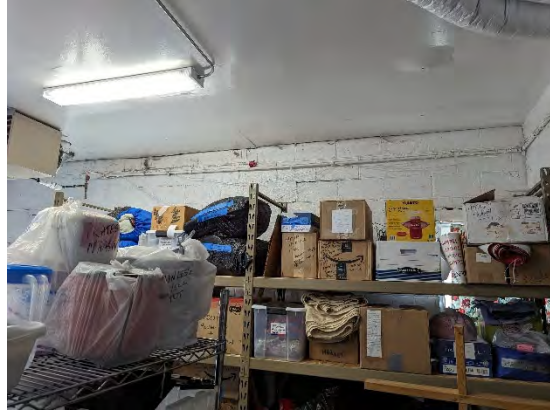
Photo 6: CMU horizontal cracking

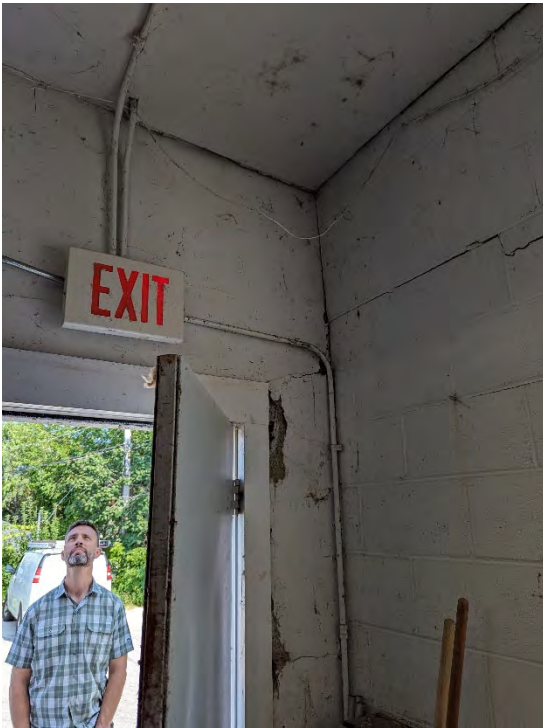
Photo 7: Interior view of NW corner

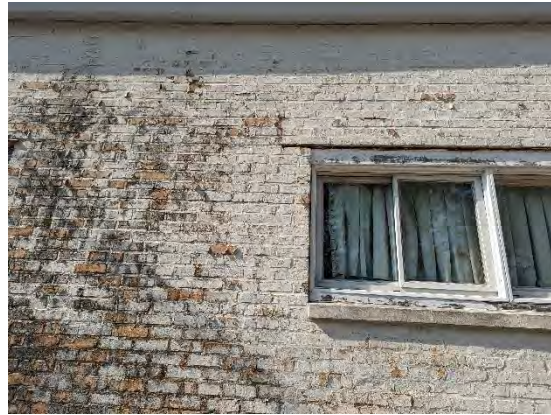
5. There is evidence of water infiltration along the rear wall. It could be from water entering through the interface of the wall, roofing and gutter. It also appears that water has been running down the face of the brick in some locations. (*Photo 8*)

Photo 8: Header with One Cripple

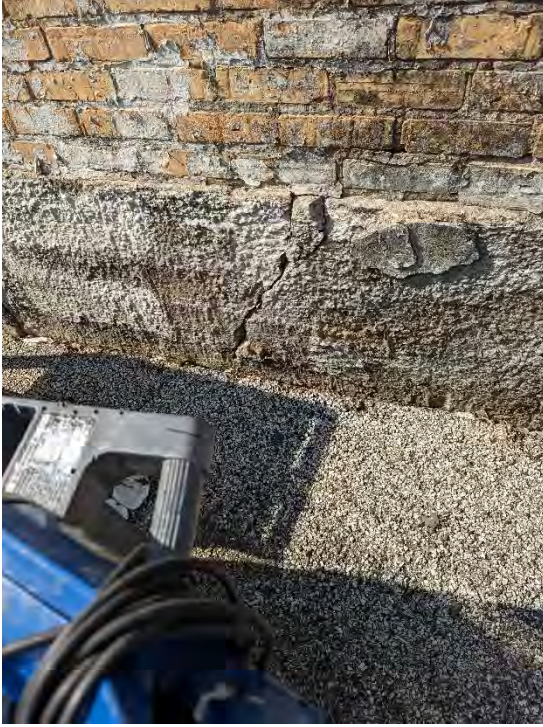
6. There are cracks in the rear foundation wall. This could be due to settlement. The wall appears to have been skim coated. Some of this has spalled off. (*Photo 9*)

Photo 9: Foundation cracking

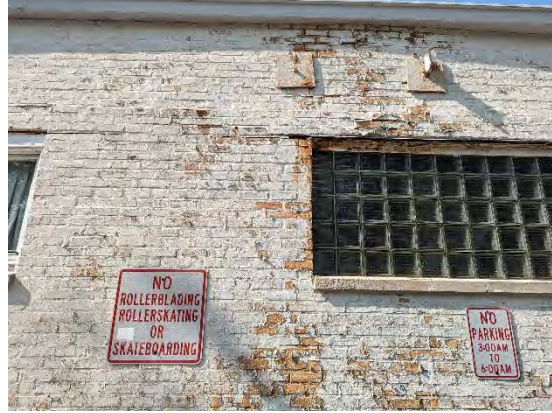
7. Along the rear elevation there are two steel plates through bolted to the wall above the west window. These do not presently appear to be serving any purpose. Consideration should be given to removing these as this can be another point of water infiltration. (*Photo 10*)

Photo 10: Steel plates at rear wall
