# BANGS LAKE LAKE MANAGEMENT PLAN 2024-2028

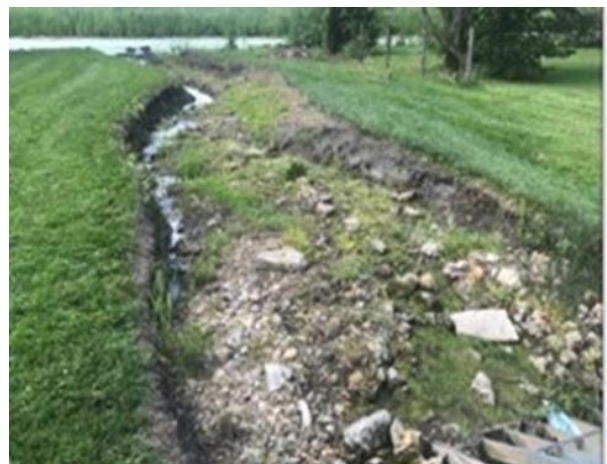
Degraded conveyance

*Village-owned vacant land located North of Circle Channel* exhibits severe erosion along the channel shoreline as well as the conveyance that feeds into Circle Channel. **It is recommended that the Village naturalize this 0.15-acre property, including shoreline and conveyance restoration.** This will support reduced nutrient loading into the lake, deter geese, and improve aesthetics. This will also serve as another example of best management practices regarding shoreline restoration (Appendix 1) for stakeholders on their properties.

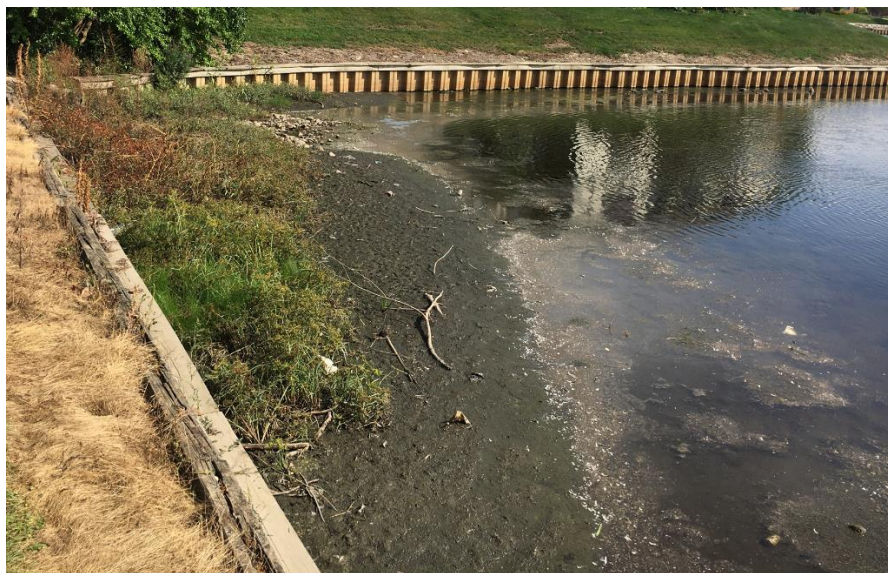
Example of a channel filled with sediment (photo source: ILM Environments)

When significant rainfall events occur, stagnant channel water migrates to the main lake carrying with it high concentrations of phosphorus. **It is recommended to remove sediment from the channels by dredging** which will result in the following benefits:

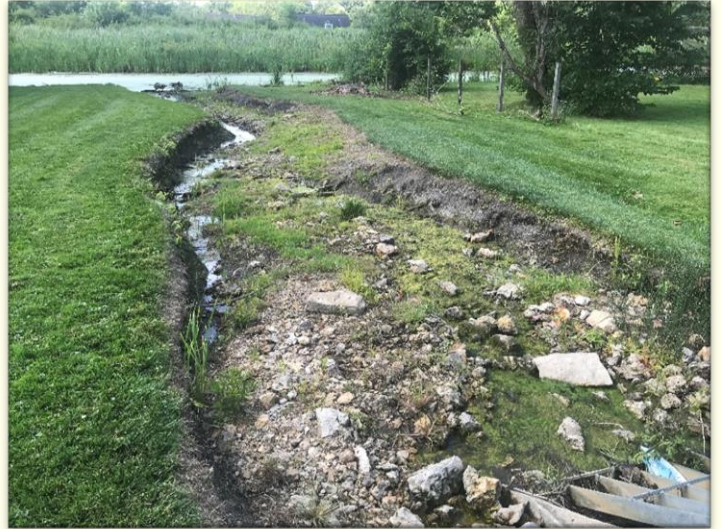
**Photo #4:** Heavily degraded inlet north of circle channel. Restoration of this area is highly suggested.

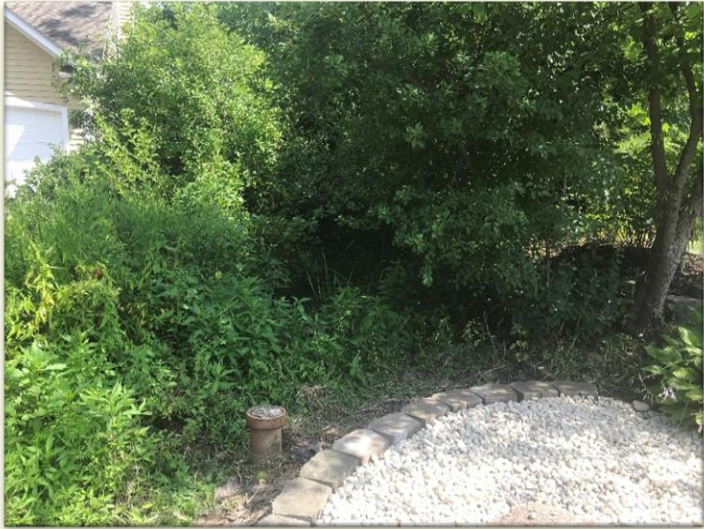
**Photo #9:** Tributary along the southwestern section of circle channel. Overgrown and degraded.

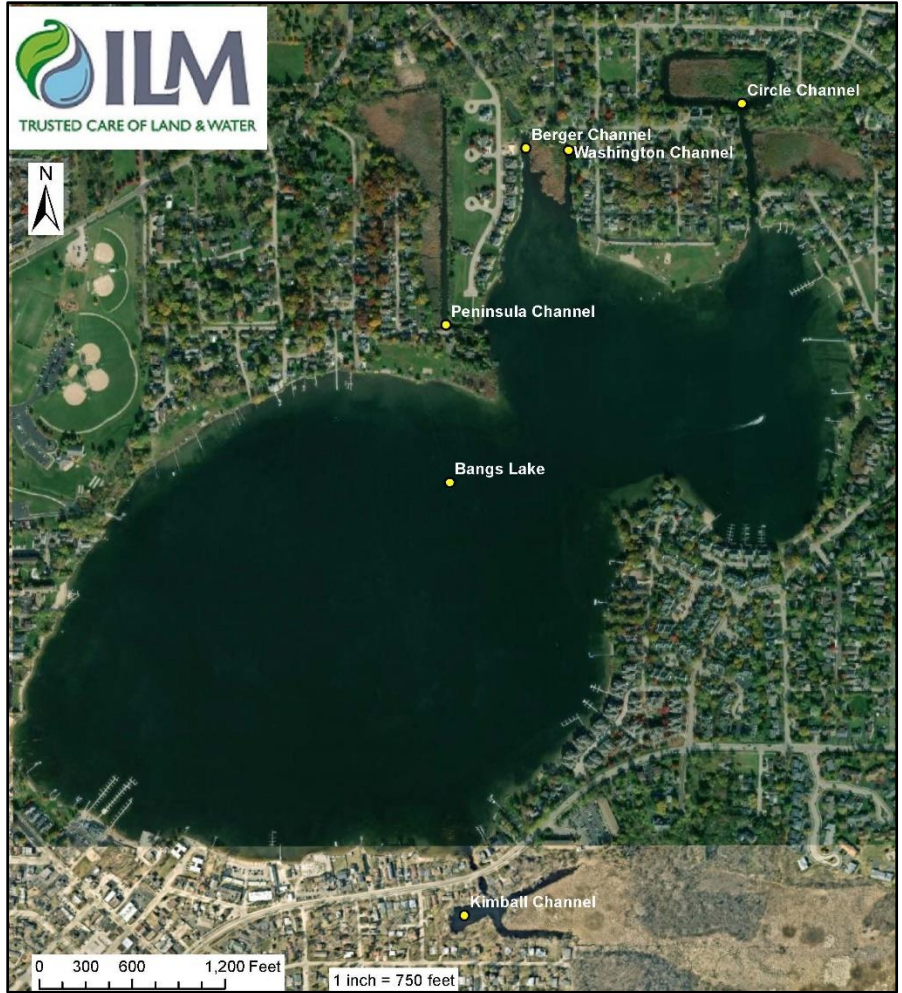
**Figure 4-5:** Sample site locations for 6/27/23.

Sample sites for the channels were chosen based on the location of the deepest point (Figure 4-5). However, the more mixing/direct exchange of water the channels have with the main lake, the “better” the water quality (ex. Berger Channel). This does not reflect enhanced water quality, more so the reduced ability of these channels to sequester nutrients before they reach the main lake such as Circle Channel and Peninsula Channel. If more sampling occurred within the channels, it’s likely this trend would be evident. This is especially true with longer channels such as the Circle Channel and Peninsula Channel. Kimball Channel water level was below the dam, no mixing with lake water occurred to skew results.

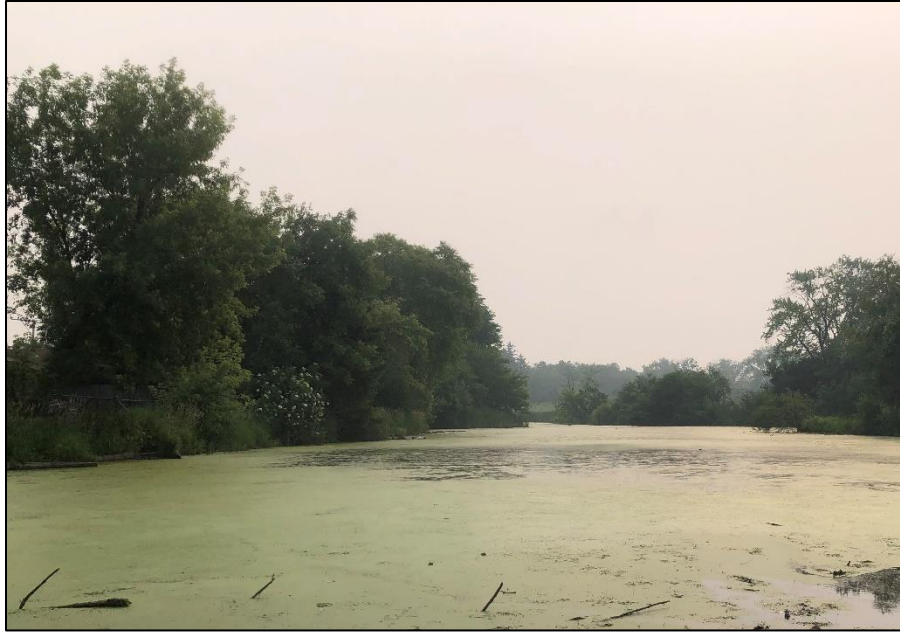
**Photo 4-1:** Kimball Channel contained heavy growth of Wolffia on 6/27/23.

Several of the channels had growth of the floating plant *Wolffia* sp., which is an indicator of high nutrient loading and low water movement. *Wolffia* was dominant in the Kimball Channel (Photo 4-1) and Circle Channel. *Wolffia* was noted in the stagnant sections on all the channels.

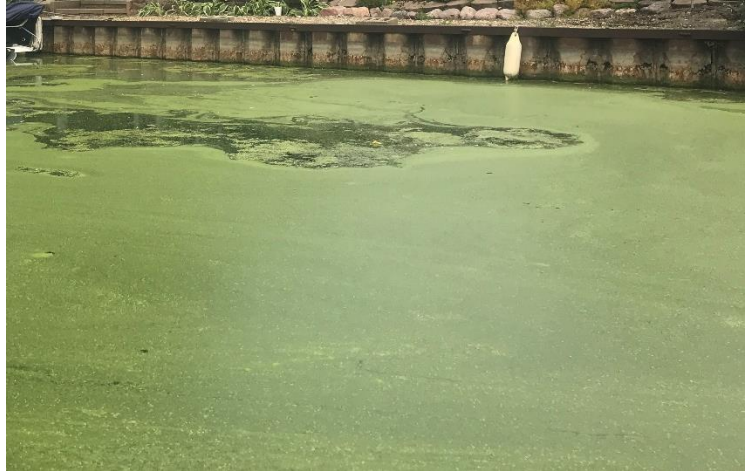
**Photo 5-1:** Example of corroding/compromised seawall on Bangs Lake.

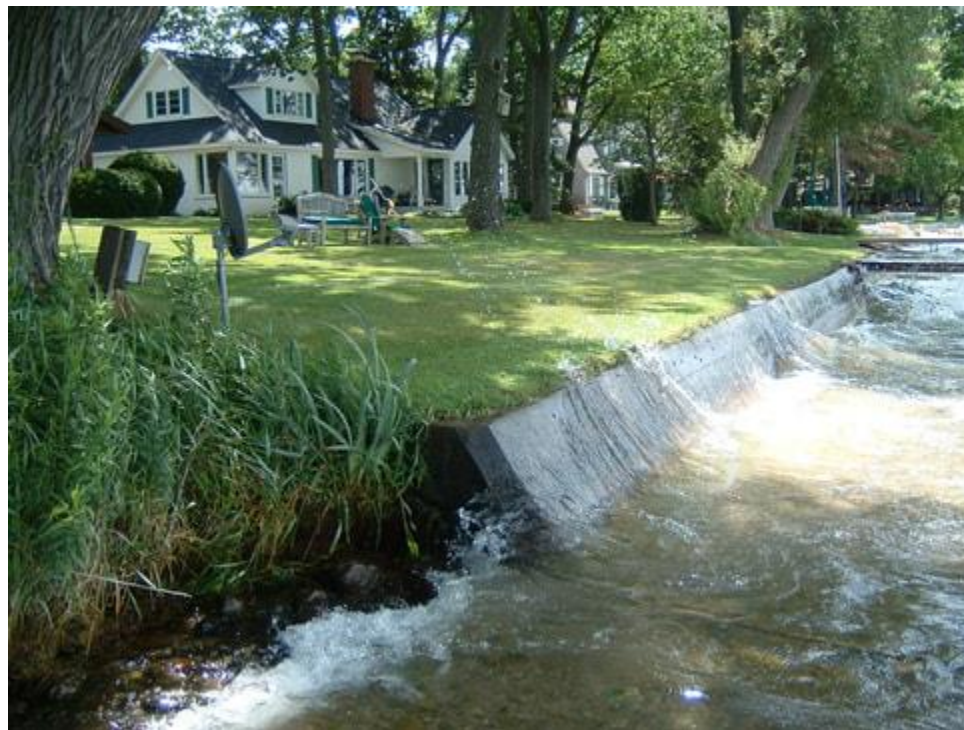
**Image 5-6:** Example of flanking damage to adjacent shorelines (Photo source: Michigan Natural Shorelines Partnership)

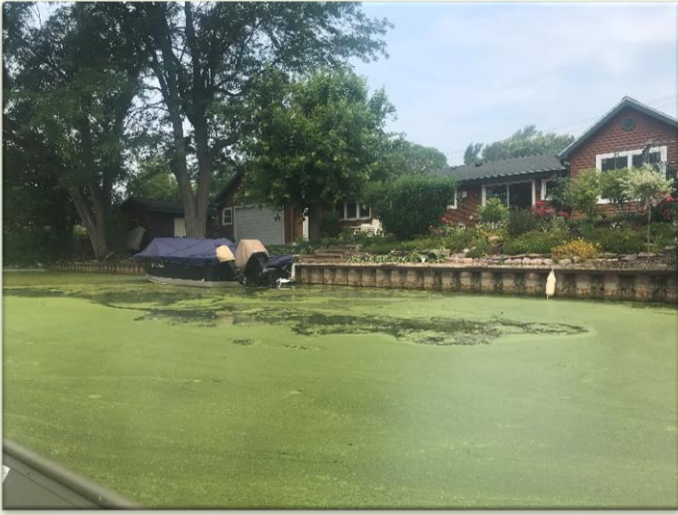
**Photo #1:** Corroding seawall in circle channel.

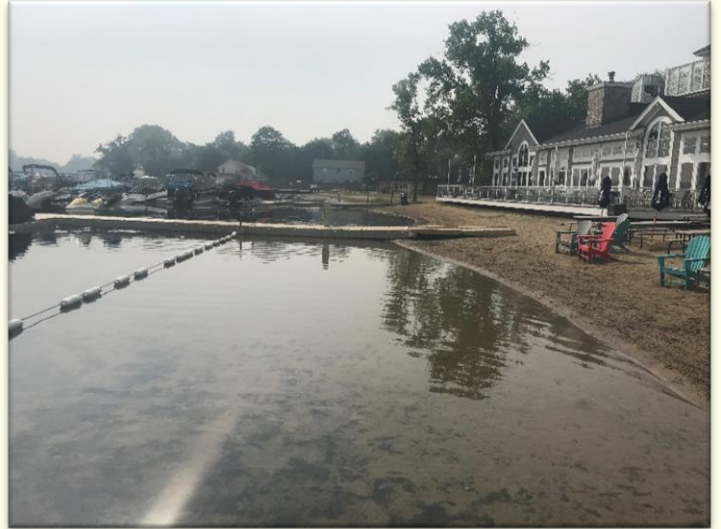
**Photo #2:** Much of the shoreline is beachfront. These areas are generally maintained for erosion by shoreline property owners. Areas like this could improve by incorporating native landscaping in portions of the beach, while maintaining recreation potential.

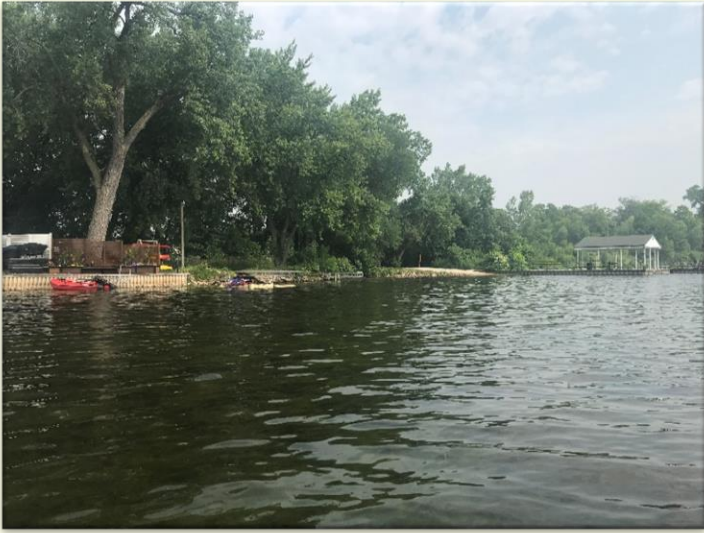
**Photo #5:** Aging shoreline and degraded natural areas.

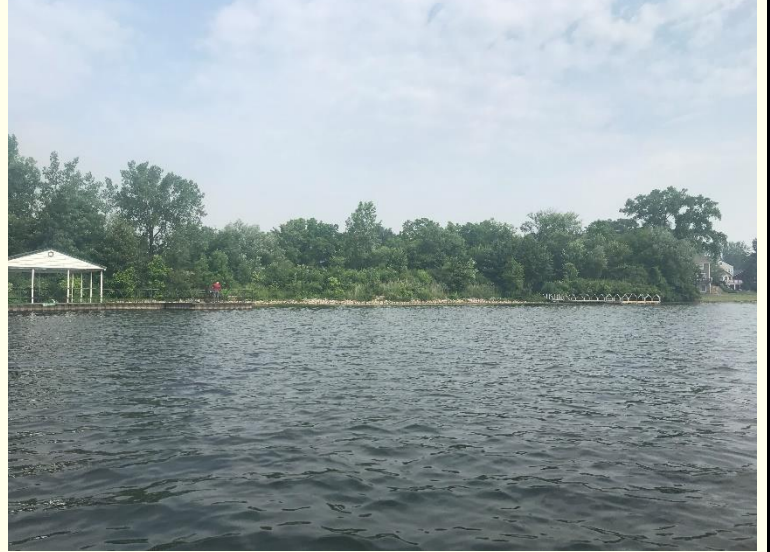
**Photo #6:** Overgrown invaded shoreline on park district property. This offers limited erosion control, and impacts the ability to enjoy the lake, as it is not visible from the walking path.

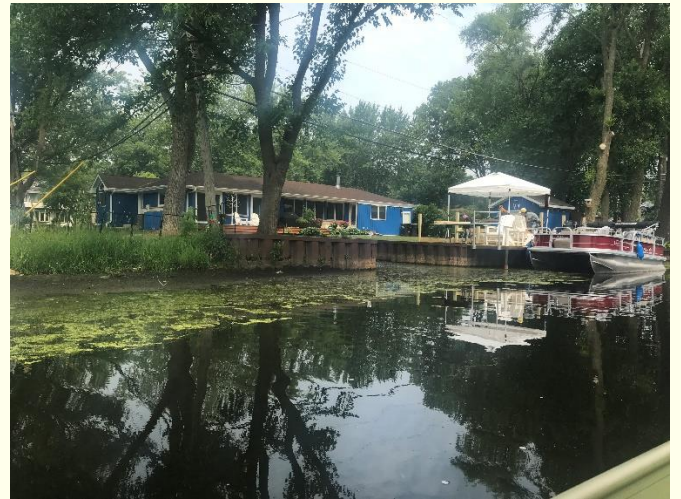
**Photo #12:** Degrading seawall, unmanaged natural areas.

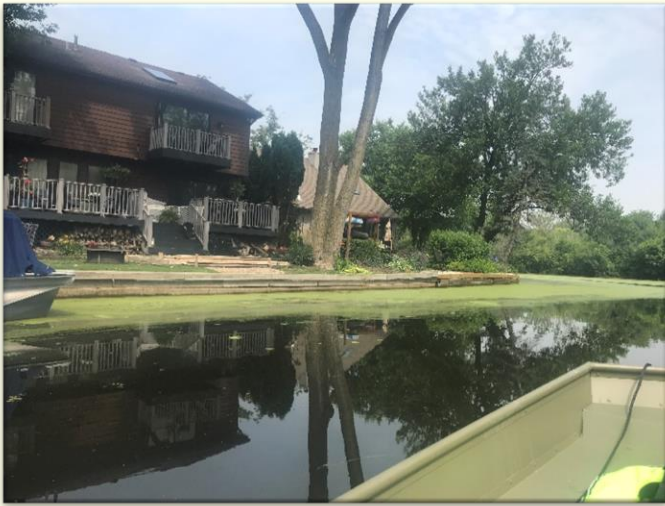
**Photo #13:** Newly installed timber shoreline control. If maintained routinely, can be effective means of control in areas with limited options.

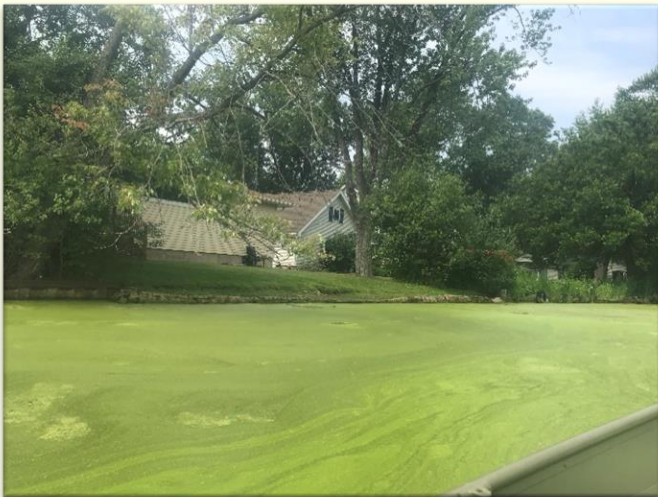
**Photo #15:** Older rip-rap now offering limited shoreline protection.

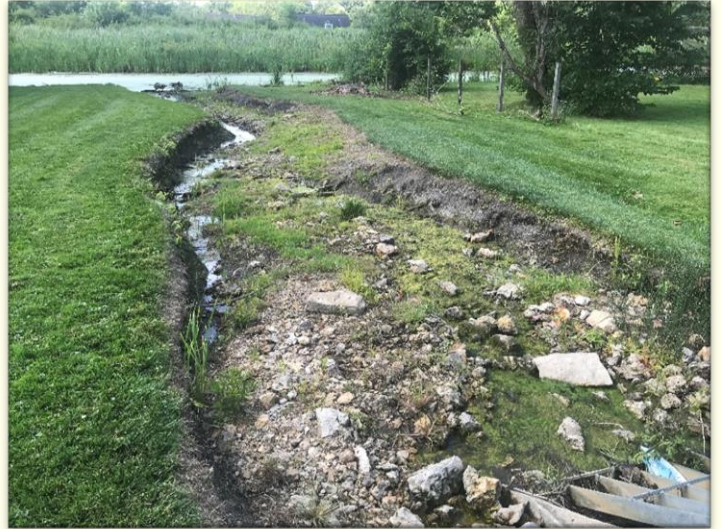
**Photo #2:** Heavily degraded inlet north of circle channel. Restoration of this area is highly suggested.

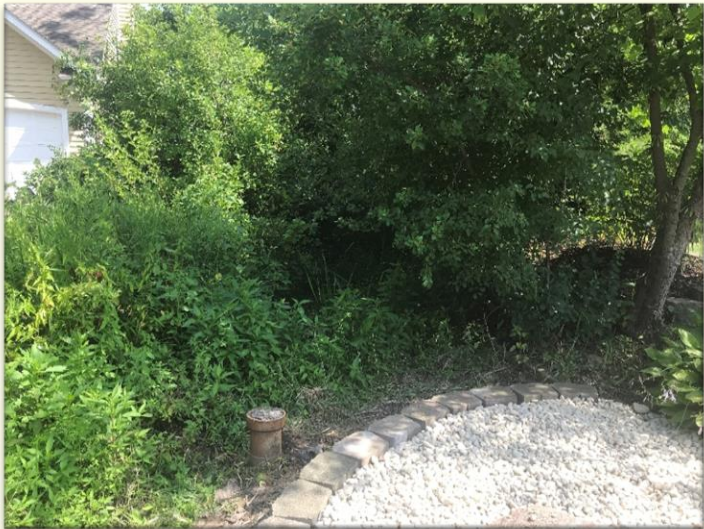
**Photo #7:** Tributary along the southwestern section of circle channel. Overgrown and degraded.
